Leica Geosystems **TruStory**

Monitoring of Rail Tracks and Construction Site

Reconstruction of the 100 year old railway bridge carrying two railtracks.

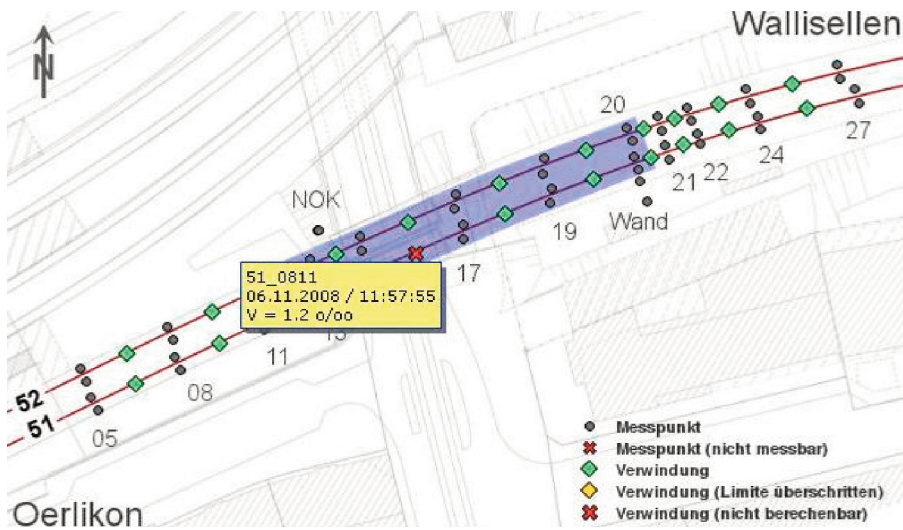
Start view of BSF Swissphoto's own client portal. The interactive map which comes up with all monitoring points and their actual state of measurements. The red lines represent the two rail tracks and the green diamonds indicate the specific torsion.

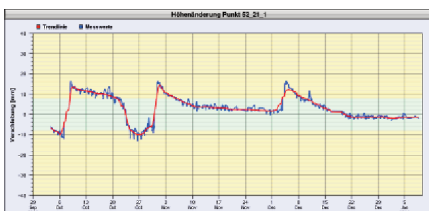
Single point settlement and uplift after mechanical track alignments on the dam.

Actual deformations of rail geometry (settlement, torsion, and longitudinal profile) were based on the positional change of each monitoring prism. Site measurements were automatically transmitted to Leica's GeoMoS Software located in the office. In the case that the restrictive limits of the railway company were exceeded, SMS and e-mail alarms were sent to the responsible persons. Possible problems with the rail alignment could also be determined and fixed quickly and efficiently.

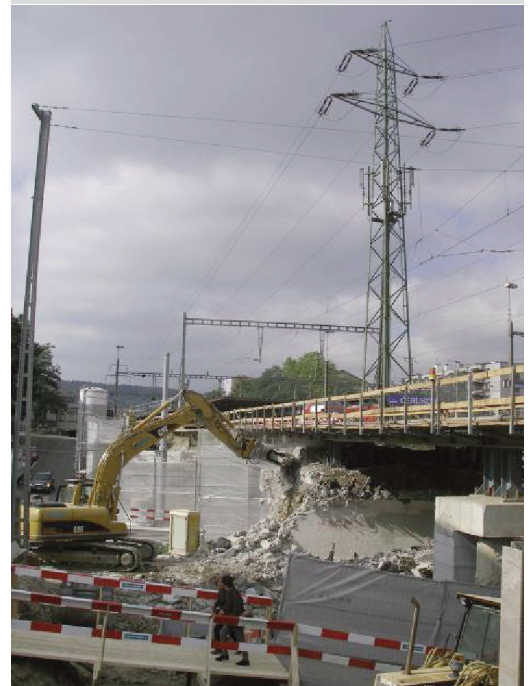
During demolition of parts of the foundation of the power line pylon, the monitoring system was used to detect 3D deformations and the resulting change in tilt.
